Contract #: 04-0120F4Cty: SF/ALA Rte: 80 PM: 13.2/13.9File #: 1.28**WELDING INSPECTION REPORT****Resident Engineer:**Siegenthaler, Peter**Address:** 333 Burma Road**City:** Oakland, CA 94607**Report No:** WIR-025079**Date Inspected:** 08-Jul-2011**Project Name:** SAS Superstructure**OSM Arrival Time:** 700**Prime Contractor:** American Bridge/Fluor Enterprises, a JV**OSM Departure Time:** 1530**Contractor:** American Bridge/Fluor Enterprises, a JV**Location:** Jobsite**CWI Name:** As listed below**CWI Present:** Yes No**Inspected CWI report:** Yes No N/A**Rod Oven in Use:** Yes No N/A**Electrode to specification:** Yes No N/A**Weld Procedures Followed:** Yes No N/A**Qualified Welders:** Yes No N/A**Verified Joint Fit-up:** Yes No N/A**Approved Drawings:** Yes No N/A**Approved WPS:** Yes No N/A**Delayed / Cancelled:** Yes No N/A**Bridge No:** 34-0006**Component:** SAS OBG**Summary of Items Observed:**

Quality Assurance Inspector (QA) Douglas Frey was at the American Bridge/Fluor (ABF) job site at Yerba Buena Island in California between the times noted above in order to monitor Quality Control functions and the in process work being performed by ABF personnel. The following items w

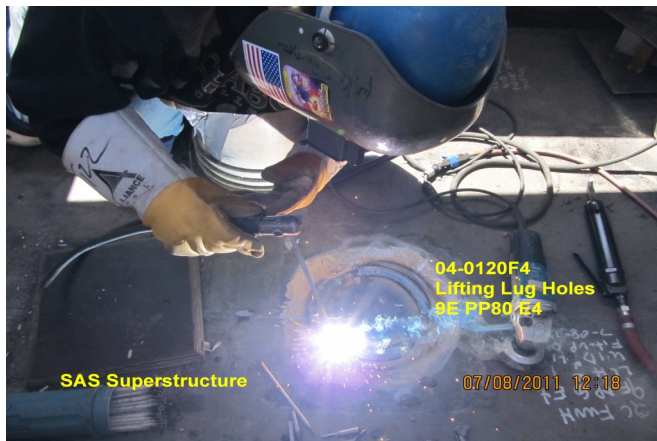
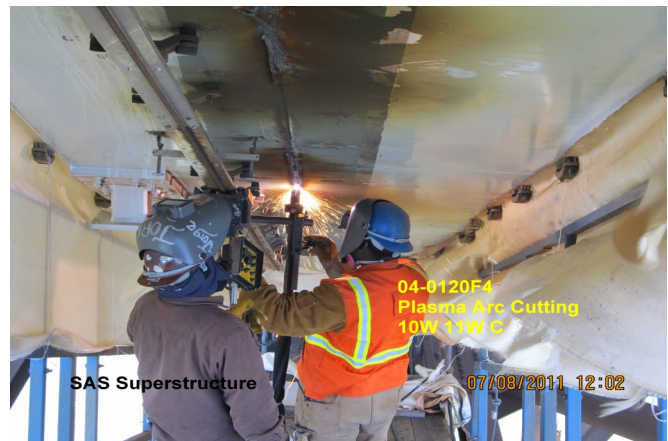
The QA Inspector observed ABF welder Mike Jiminez ID# 4671 performing Shielded Metal Arc Welding (SMAW) in the 1G flat position on Lifting Lug Hole's (LLH) #1 and 3 located at 9E PP80 E4. Prior to welding the QA Inspector observed QC Inspector Fred Von Hoff inspecting the fit up of the joint and the QA verified the fit up alignment of the two access holes which were deemed acceptable as pertaining to the contract requirements. The QA Inspector observed the QC Inspector monitoring the progress to ensure the welding parameters were in compliance pertaining to ABF-WPS-D15-1050A-CU. The work is in progress and the QA Inspector noted that the work appeared to be in general conformance with the contract documents.

The QA Inspector observed ABF welder Wen Han Yu ID# 6317 performing SMAW in the 3G vertical position on Plate Splice F located at 10E 11E F1. The QA Inspector observed the QC Inspector Fred Von Hoff monitor the progress and ensure the welding parameters were in compliance pertaining to ABF-WPS-D15-1040A Rev.1. The work was completed on this date and the QA Inspector noted that the work appeared to be in general conformance with the contract documents.
